APS Inspection Service  
1582 Victoria Ave  
Lakewood, OH 44107

# Home Inspection

Sample Report  
1234 School House Road  
Yourtown, US 12345

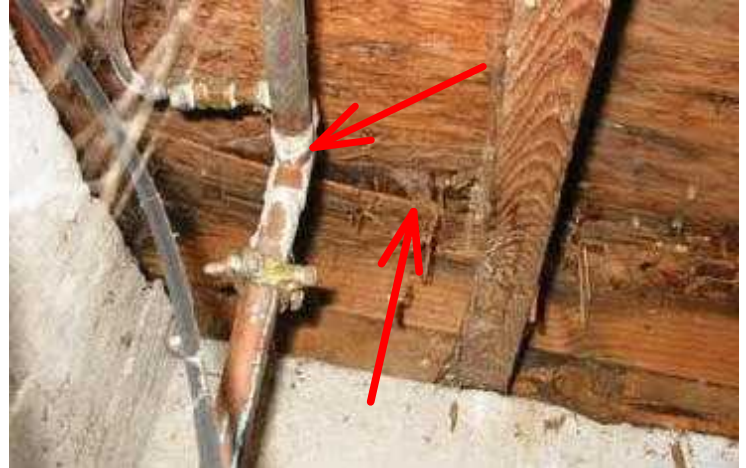
Wood rot and possible plumbing leak

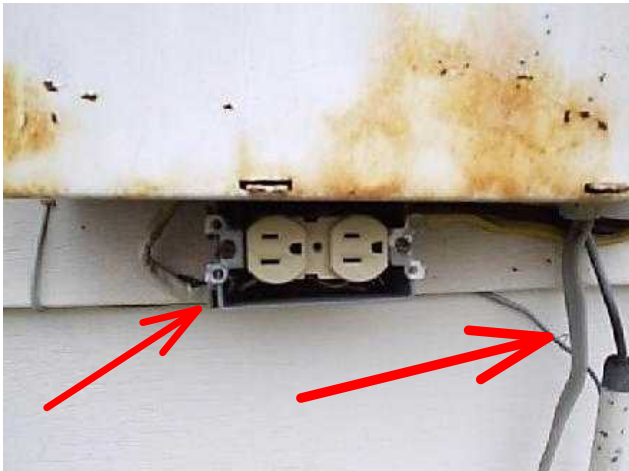
Improper wiring and outlet cover missing

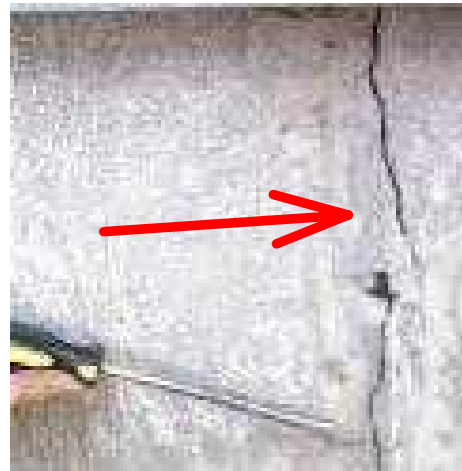
Foundation crack with displacement

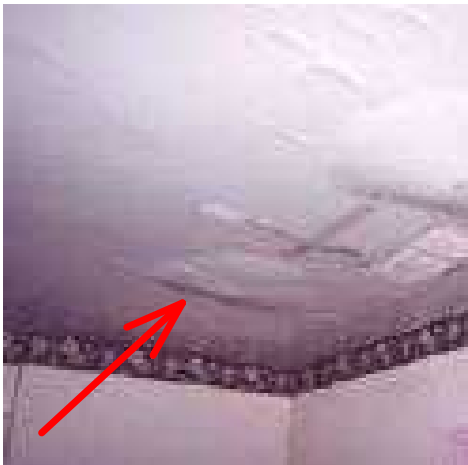
Water damage in living room ceiling

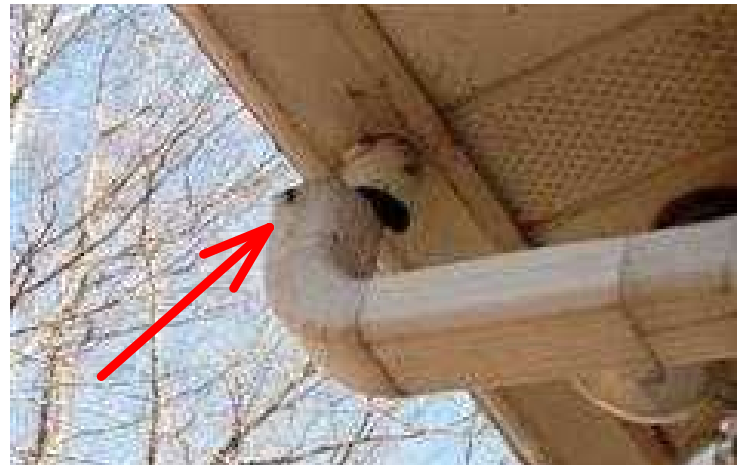
Down spout loose

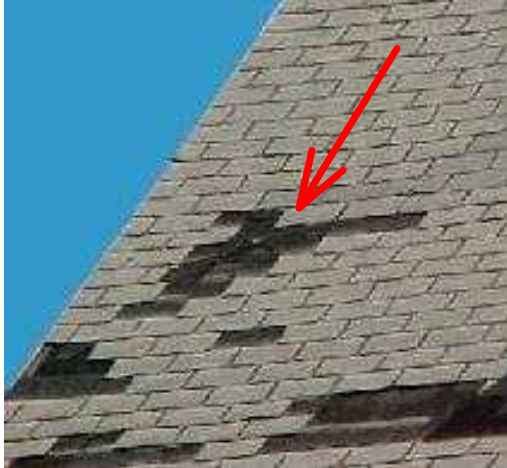
Shingles missing

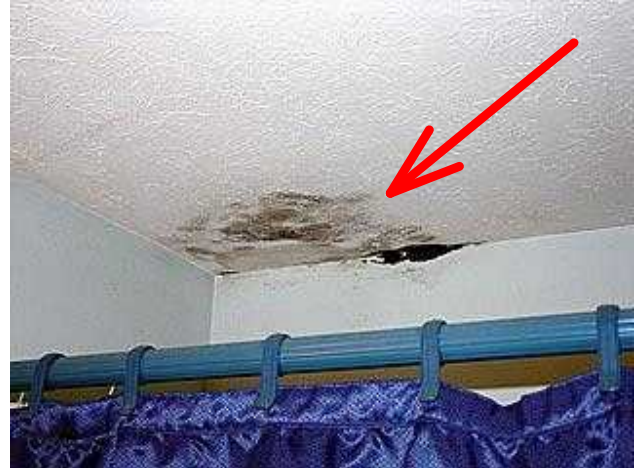
Possible visible mold and water leak

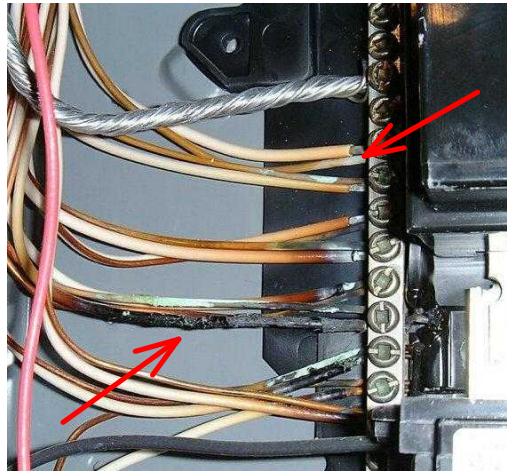
Double taps and burnt wiring

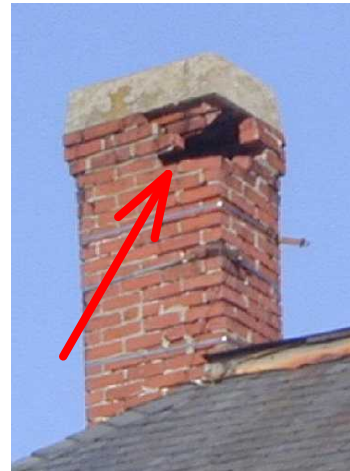
Bricks missing from chimney

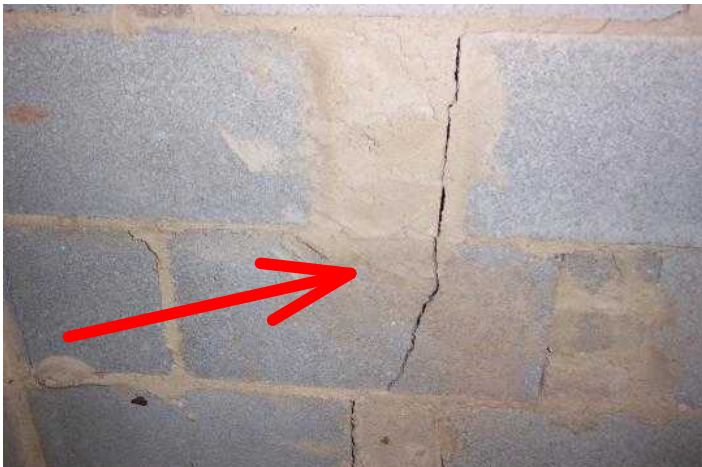
Foundation crack

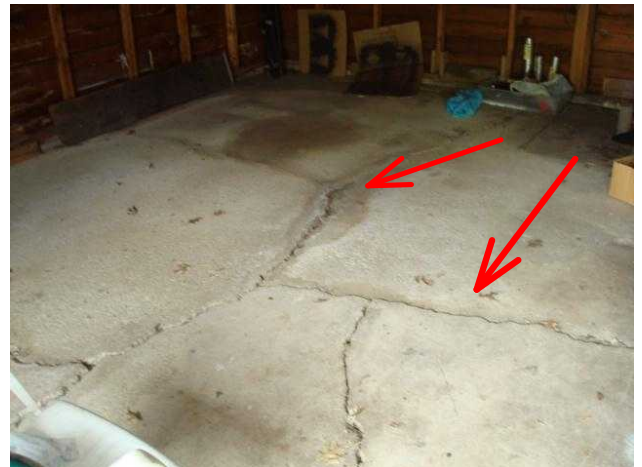
Garage floor cracked with displacement

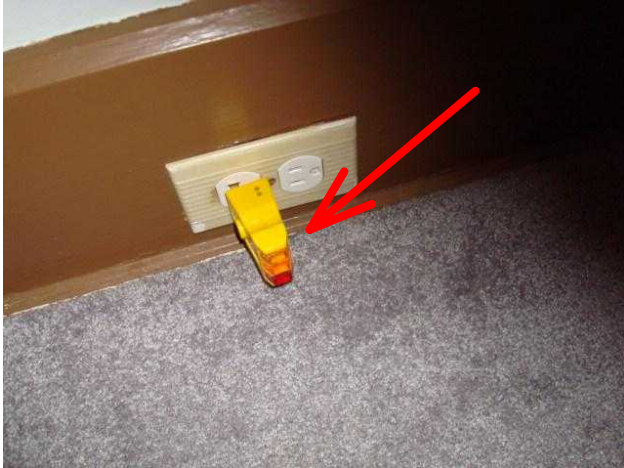
Ground missing

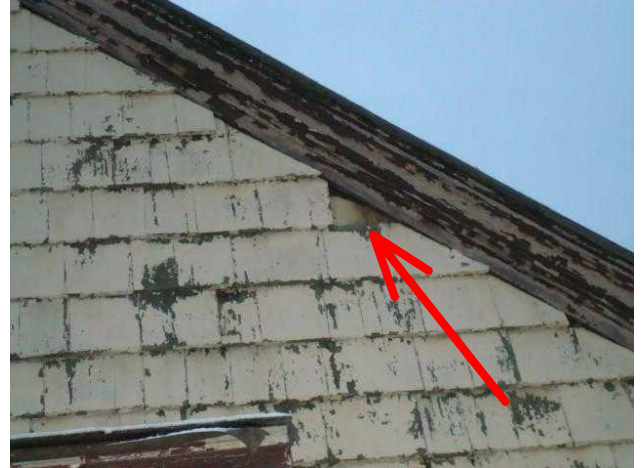
Missing siding and needs scraped and painted

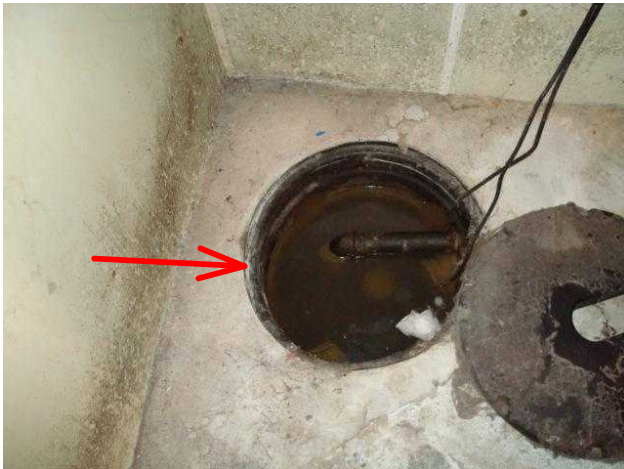
Sump pump inoperative

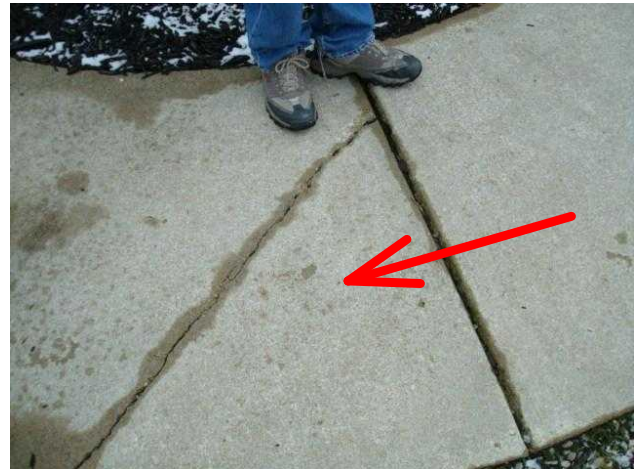
Settlement in the sidewalk

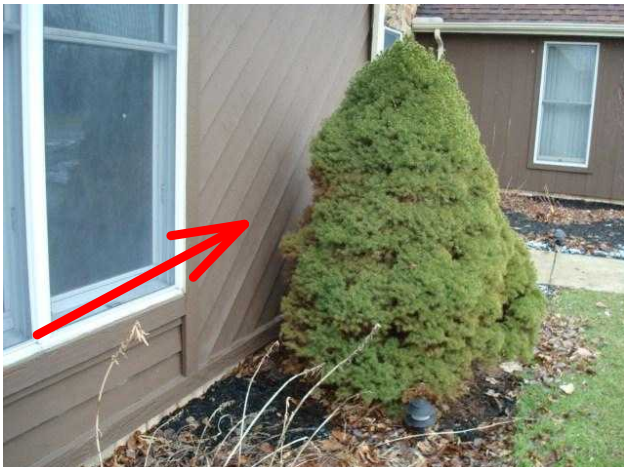
Shrub should be trimmed 12" from the home

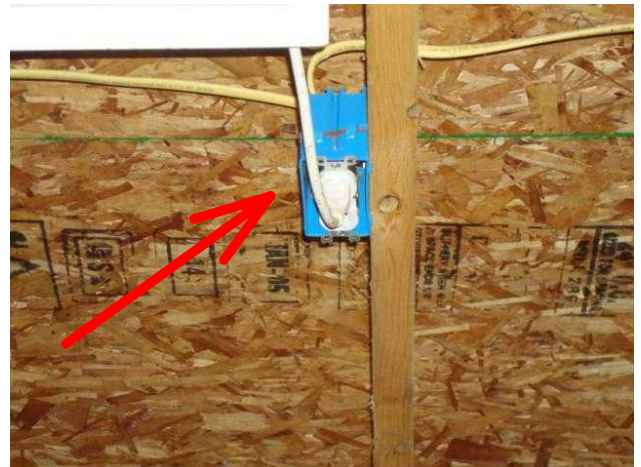
Outlet cover missing

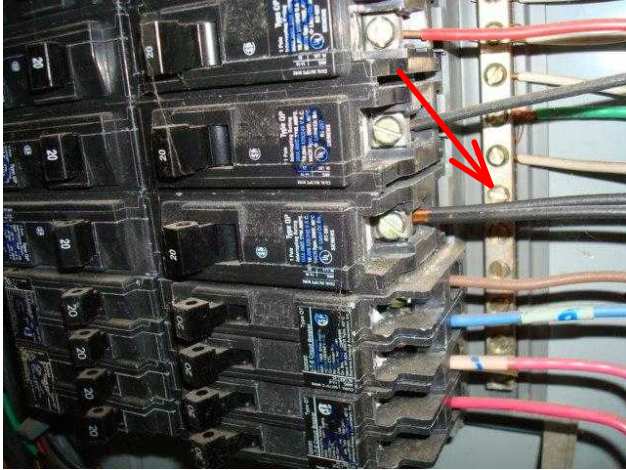
Double tap present

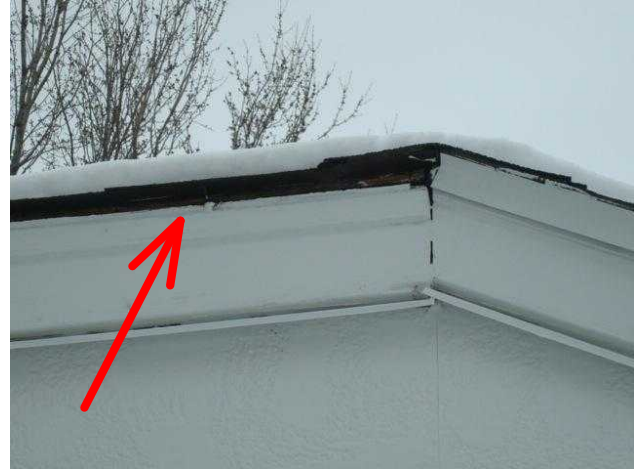
Drip edge missing

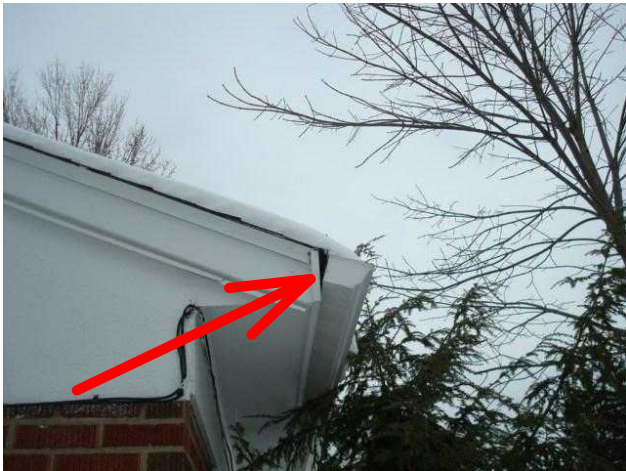
Gutter loose

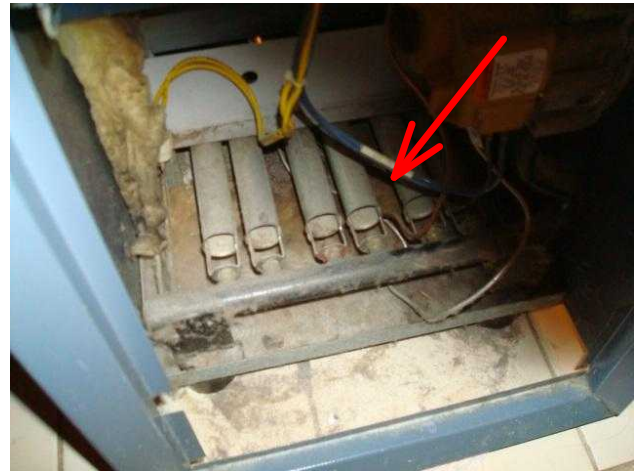
Boiler needs cleaned and serviced and heat exchanger checked for cracks.

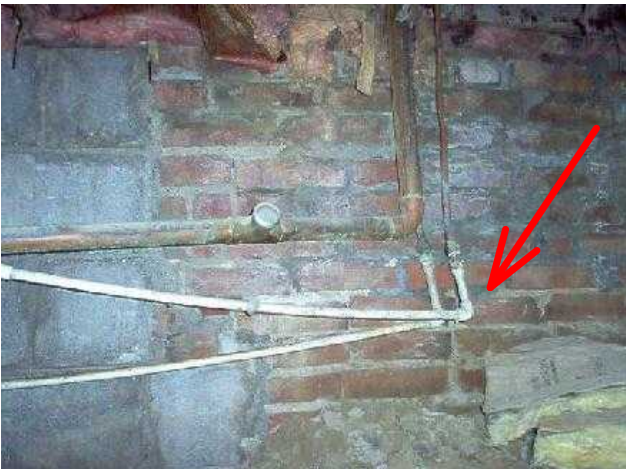
Pipes are not secure and leaking

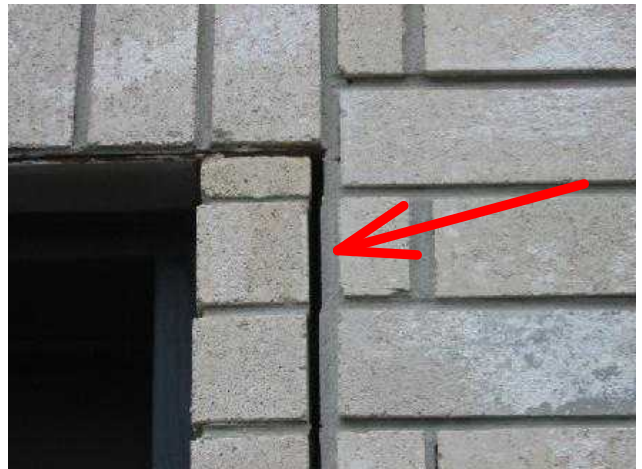
Separation of brick at window

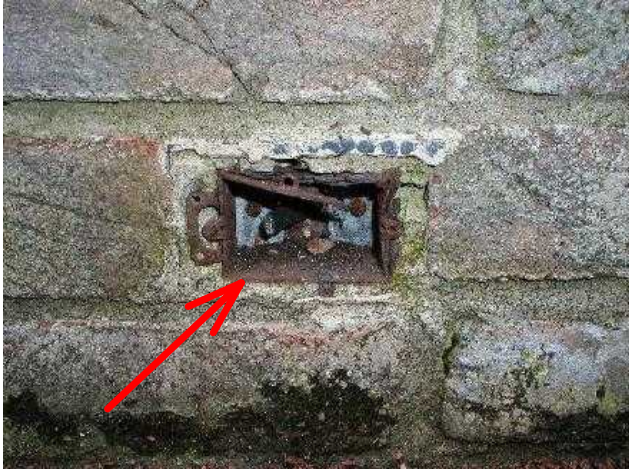
Outlet rusted out

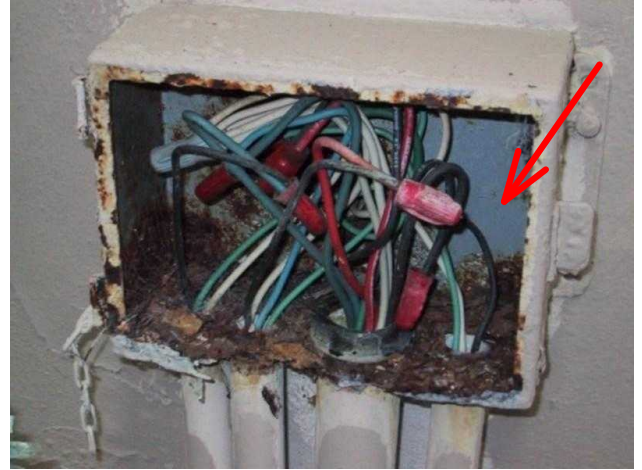
Cover missing and rusted
